# LASERGAUGE®

## Automated Gap/Flush Measuring System for 100% Inspection

October 5, 2018

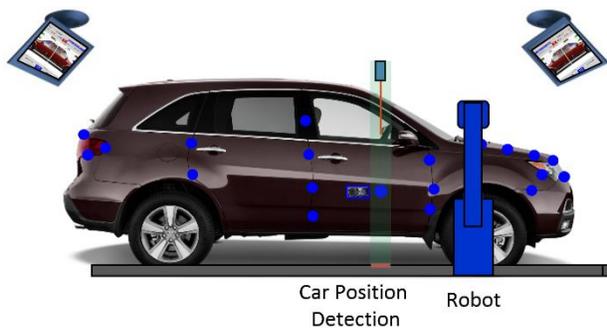
LGAutomation is a robot-driven automated inspection station for 100% gap/flush measurement on the final assembly line. Integrated into the manufacturing line by plant personnel or independent robot integrators, the EOAT sensor system automatically acquires fit and finish measurements on a vehicle in real-time on a moving line using proven, flexible measurement methodologies. To eliminate any requirement for a stop station or to “pin” the automobile in a known location, a vehicle tracking subsystem tracks the position and orientation of the automobile for real-time robot path correction to ensure that the measurements are taken in the same position each time, regardless of the automobile’s position.

LGAutomation utilizes one robot on each side of the vehicle for left/right side inspection. More robots/sensors can be added as necessary if more measurement points are needed or if the two-robot configuration is unable to keep up with the line speed. Robots can be floor- or gantry-mounted as needed to access the desired measurement locations.

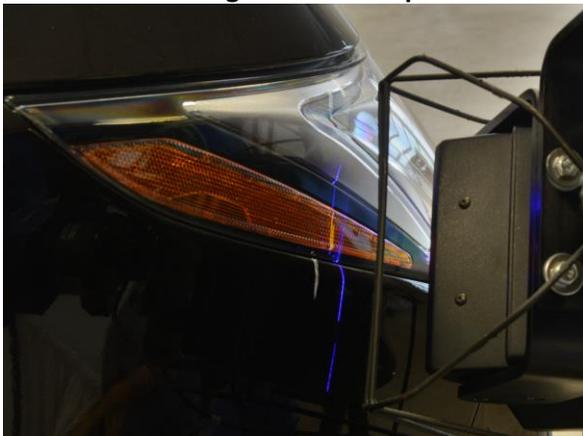
**Scanning on Head Lamp**

In addition to the Cross-Vector scanning capability, the RS763 utilizes blue-laser scanning technology and advanced signal processing algorithms. This allows the sensor to scan almost all surfaces on an automobile: body panels, headlamps, tail lamps, window glass and chrome. No other gap/flush system has the blue laser Cross-Vector capability.

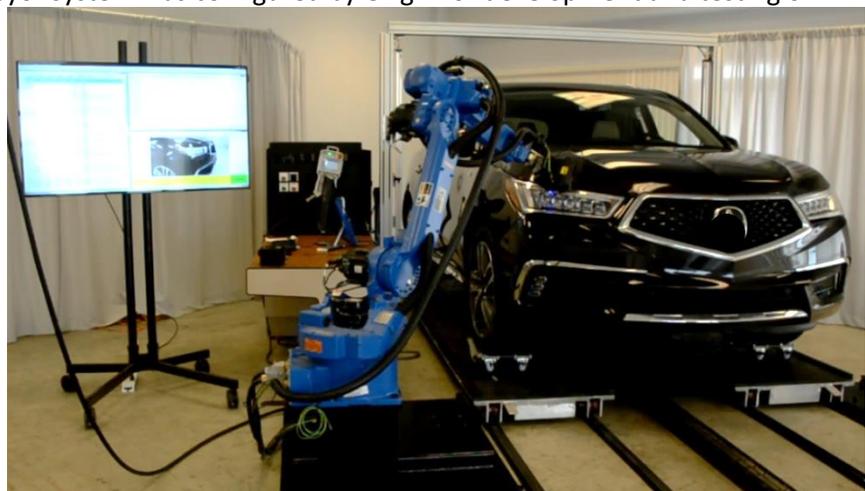
To put the system to the test, a major automobile manufacturer provided their requirements for an automated inspection system. Specific points/point types were identified and a vehicle was specified and provided for this test. A conveyor system was configured by Origin for development and testing of the LGAutomation system. It consists of a single robot (only one side was measured), a chain-driven conveyor and a robot subsystem. The speed of the conveyor was set to simulate a final line with a 60 second cycle time. This photo shows the system as-configured.

The test configuration also provides a way to change the

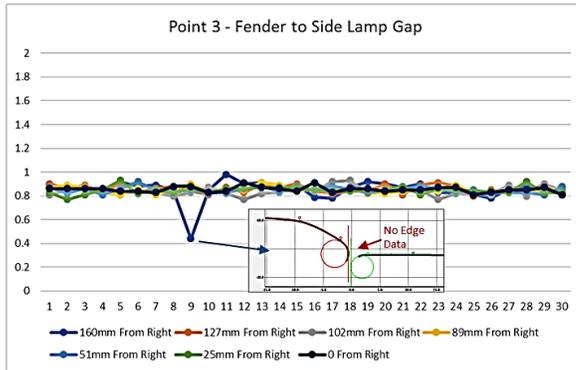
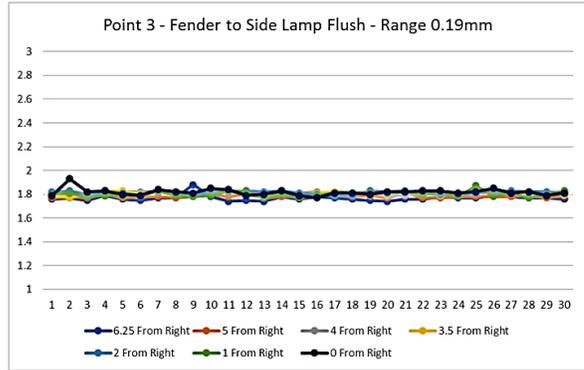
### Body-to-Side Lamp: 1 outlier

In total, 7 outliers were identified out of the 7560 measurement characteristics acquired during this testing. In each case, the outlier would easily be rejected using scan validation criteria that is set in the sensor firmware. This validation was turned off for this test so that the root cause of the errant points could be ascertained.

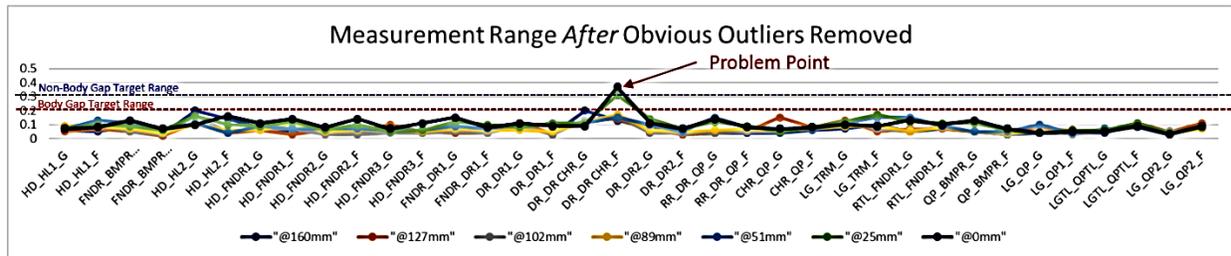
Once the outliers were removed, the complete summary plot for all 7560 points is shown:

There was one “problem point” identified. This problem point was a very difficult chrome to chrome surface with other material attached to the edges. A custom algorithm is being developed to return accurate and repeatable measurements.

The measurements acquired with LGAutomation fell well within the automobile manufacturer’s repeatability requirements on all gap types/configurations. The system was tested in 7 different vehicle positions/angles. Each run measured 36 different characteristics (18 points per run). There were 30 runs for each of the vehicle positions. In all of that testing, only 7 outlier points were identified, or ~0.1% of the values. Every outlier would be easily rejected using one of the following methods:
